**Flood Control Project Maintenance
Levee Inspections**

Fall 2013 Levee Maintenance Deficiency Summary Report

Solano County Public Works Mellin Levee

Levee Inspection Report By Mile - Fall 2013

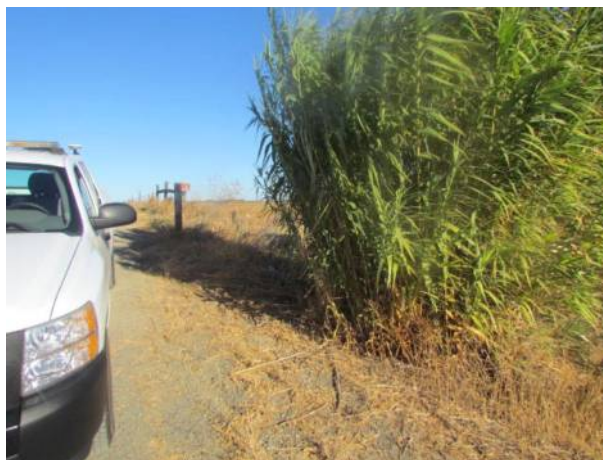
Levee Mile Report Line	4
Start Levee Mile	0.00
End Levee Mile	0.00
Location	Water Side
Category	Earthen Levee
Item	Vegetation

Looking west at Arundo on waterside slope.

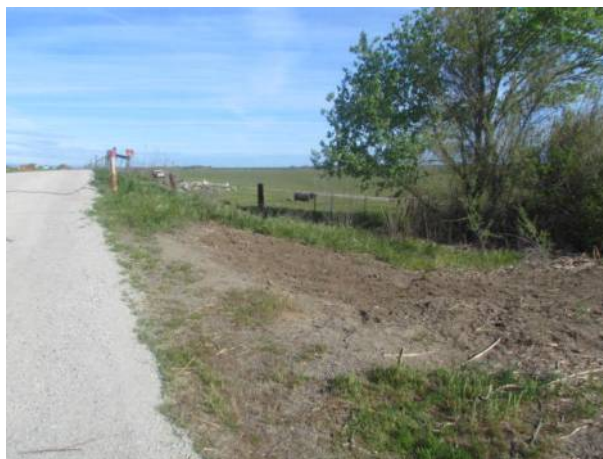
Levee Mile Report Line	4
Start Levee Mile	0.00
End Levee Mile	0.00
Location	Water Side
Category	Earthen Levee
Item	Vegetation

Looking west after district removed Arundo on waterside slope at the entrance of the project.

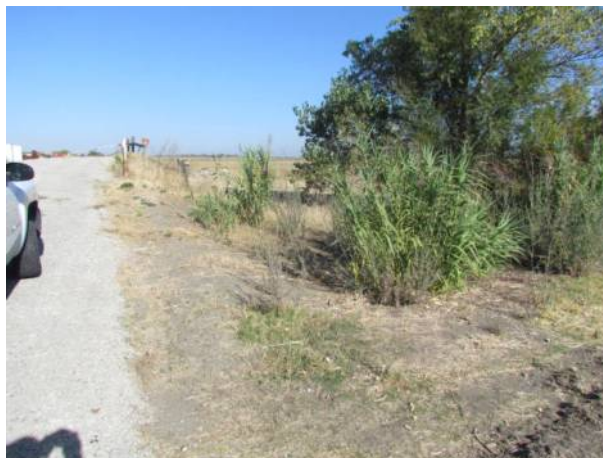
Levee Mile Report Line	4
Start Levee Mile	0.00
End Levee Mile	0.00
Location	Water Side
Category	Earthen Levee
Item	Vegetation

Looking west at Arundo on waterward slope. 2013

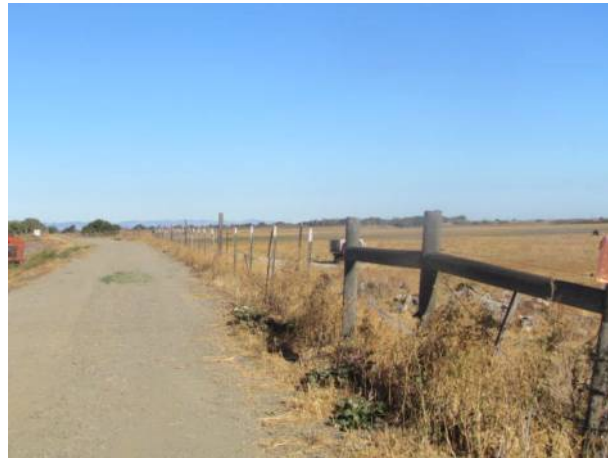
Levee Mile Report Line	5
Start Levee Mile	0.00
End Levee Mile	0.59
Location	Water Side
Category	Earthen Levee
Item	Encroachments

Looking west at fence on waterside shoulder.

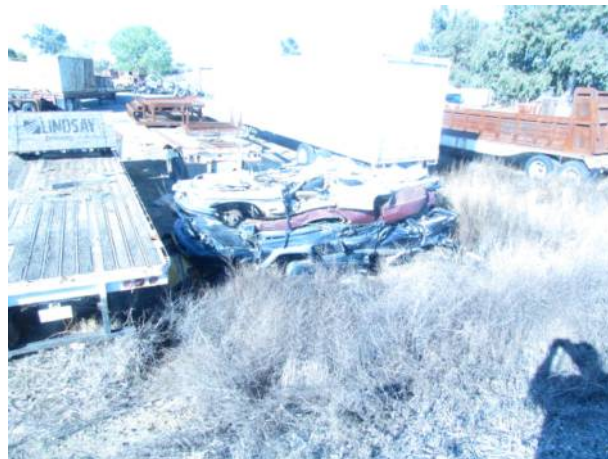
Levee Mile Report Line	6
Start Levee Mile	0.04
End Levee Mile	0.07
Location	Land Side
Category	Earthen Levee
Item	Encroachments

Looking south at crushed vehicles at landside toe.(Spring 2012)

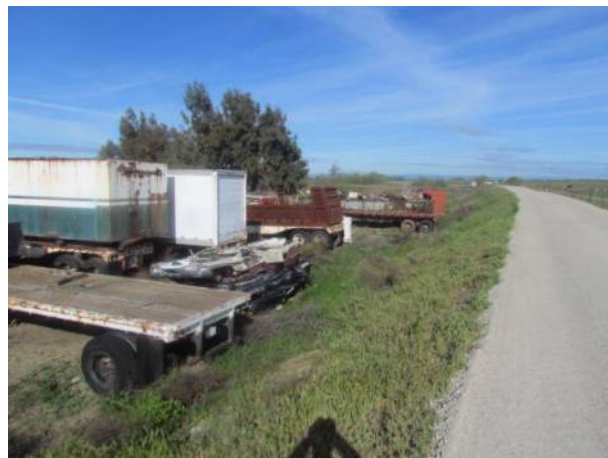
Levee Mile Report Line	6
Start Levee Mile	0.04
End Levee Mile	0.07
Location	Land Side
Category	Earthen Levee
Item	Encroachments

Looking west at crushed vehicles and trailers on landside toe.

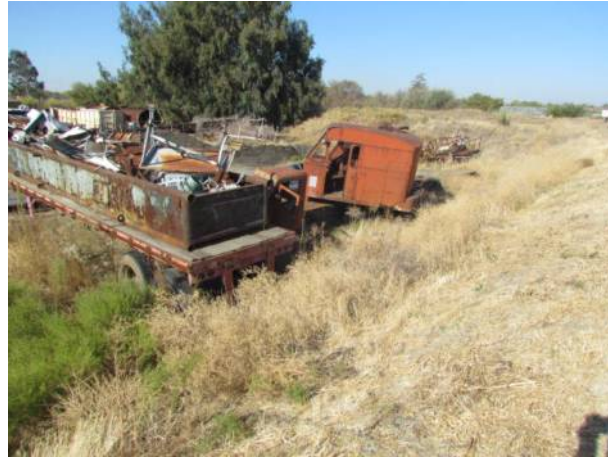
Levee Mile Report Line	6
Start Levee Mile	0.04
End Levee Mile	0.07
Location	Land Side
Category	Earthen Levee
Item	Encroachments

Looking west at equipment blocking landward toe.

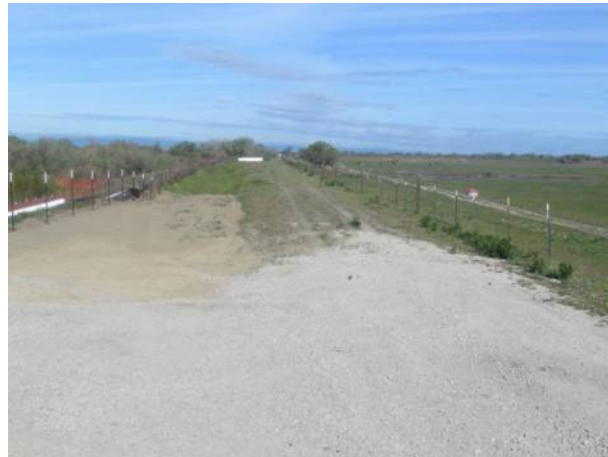
Levee Mile Report Line	8
Start Levee Mile	0.15
End Levee Mile	0.59
Location	Crown
Category	Earthen Levee
Item	Crown Surface / Depressions / Rutting

Looking west at crown roadway.

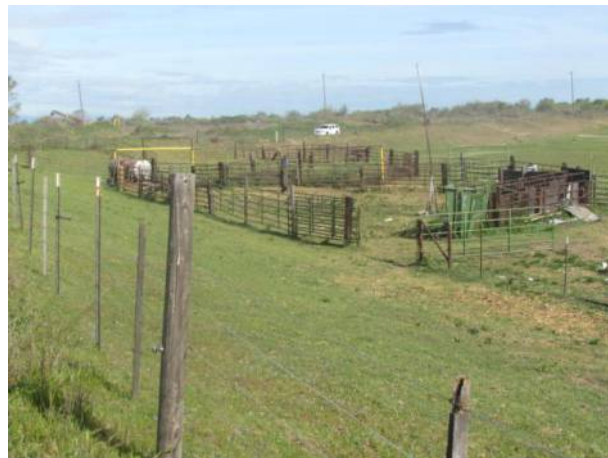
Levee Mile Report Line	9
Start Levee Mile	0.59
End Levee Mile	0.59
Location	Water Side
Category	Earthen Levee
Item	Encroachments

Looking west at animal corral on waterside toe.

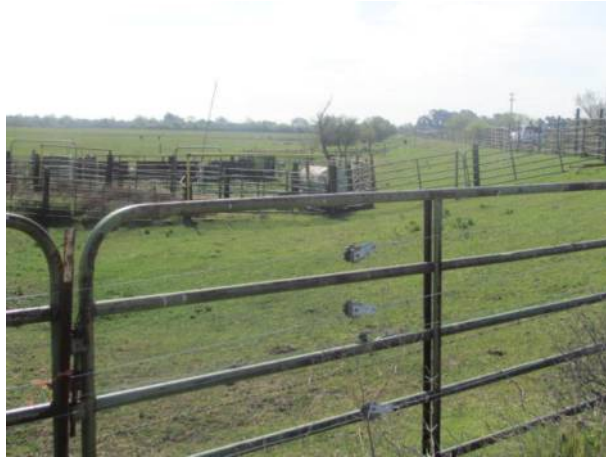
Levee Mile Report Line	9
Start Levee Mile	0.59
End Levee Mile	0.59
Location	Water Side
Category	Earthen Levee
Item	Encroachments
Looking east at animal corral on waterside toe.	
richard_f_20130930_584.JPG
